Anchor Darling Double Disc Gate Valve Wedge Pin Failure 10CFR21 and LaSalle HPCS MOV Stem Disc Separation Industry Response

Teledyne Quiklook User Group Meeting – August 17 2017

Ted Neckowicz – Senior Staff Engineer
Exelon Gen Corporate Valve Programs

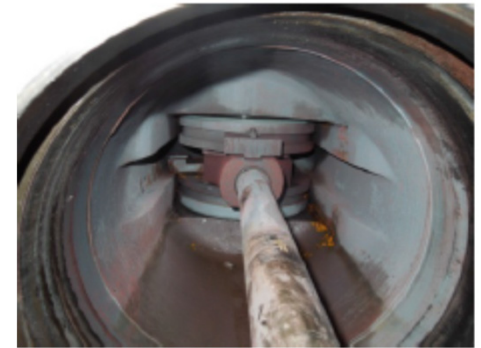
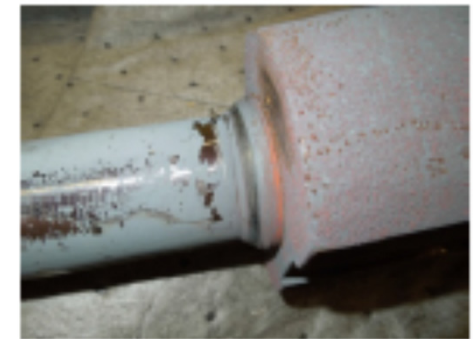
On October 20, 2012, the as-found local leak rate test (LLRT) for the Browns Ferry Unit 1 HPCI Inboard Steam Isolation Valve significantly exceeded administrative limits. The valve was subsequently disassembled to investigate the cause for the failure. This investigation revealed that the wedge pin had broken in several locations and the disc retainer had fallen from the wedge assembly and was found located between the valve discs.

Direct Cause: *The direct cause for the wedge pin shearing is rotation of the valve stem at its threaded connection to the upper wedge connection.*

Root Cause: *Station personnel failed to validate that vendor had torqued the stem to upper wedge connection per vendor's procedures which were modified in response to earlier failures of the same valve design.*

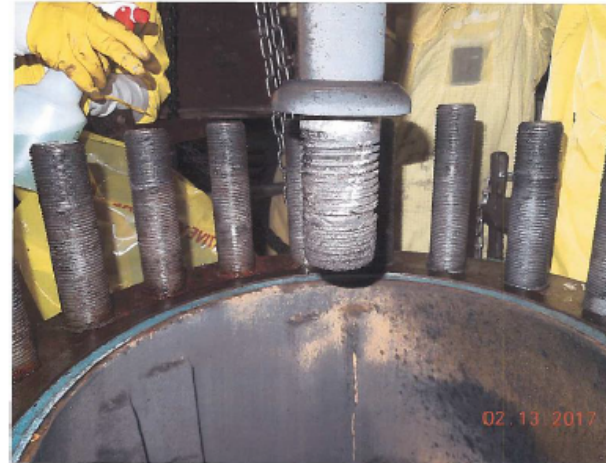
LaSalle 2E22-F004 - Stem with external threads with severe wear degradation

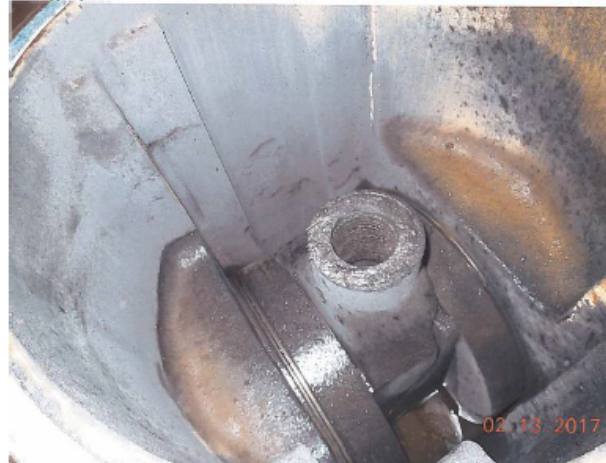
LaSalle 2E22-F004 – Upper wedge with internal threads with severe wear degradation, wedge pin was found sheared.

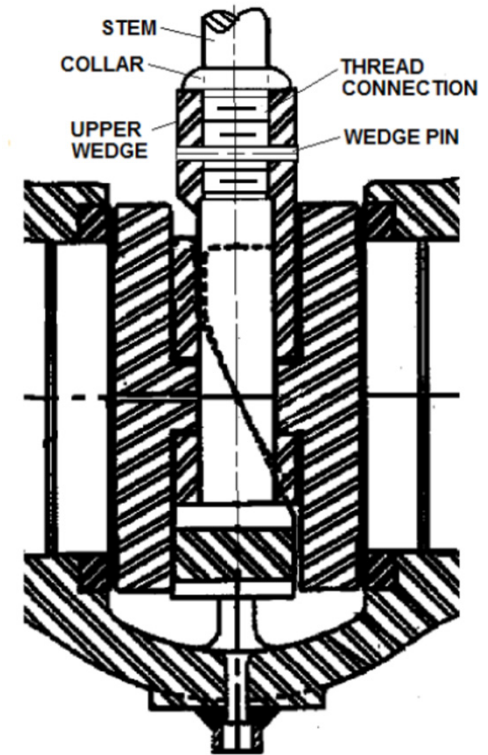
Figure 3: Stem-To-Wedge Connection

- Insufficient load (thrust) carrying capacity of the shrink fit stem
- Multiple closing high load cycles (axial thrust and torque)
- Eventual wedge pin shear failure
- Wedge and stem thread wear
 - Adhesive wear (i.e., galling)
 - Aggressive abrasive wear
- Axial shear failure of degraded wedge threads
- Contributing was the lack of pre-load with insufficient capacity of the stem collar and pin assembly

- Vulnerability and risk/consequences of failure should be factored into monitoring and repair plans
- Stem rotation checks should be performed using instruments with sufficient accuracy to support trending
- Trace differences should be thoroughly analyzed based on recent industry experience
- Structural assessment of wedge-pin connection should assume highest applied torque during time in service, which may differ from current set-up
- Weak-Link analyses of Anchor Darling Double Disc Gate Valves should fully assess the stem-wedge assembly including the thrust collar
- Replacement stems should be of the integral one-piece design
