Anchor Darling Double Disc Gate Valve Wedge Pin Failure 10CFR21 and LaSalle HPCS MOV Stem Disc Separation Industry Response

Teledyne Quiklook User Group Meeting – August 17 2017

Ted Neckowicz – Senior Staff Engineer
Exelon Gen Corporate Valve Programs

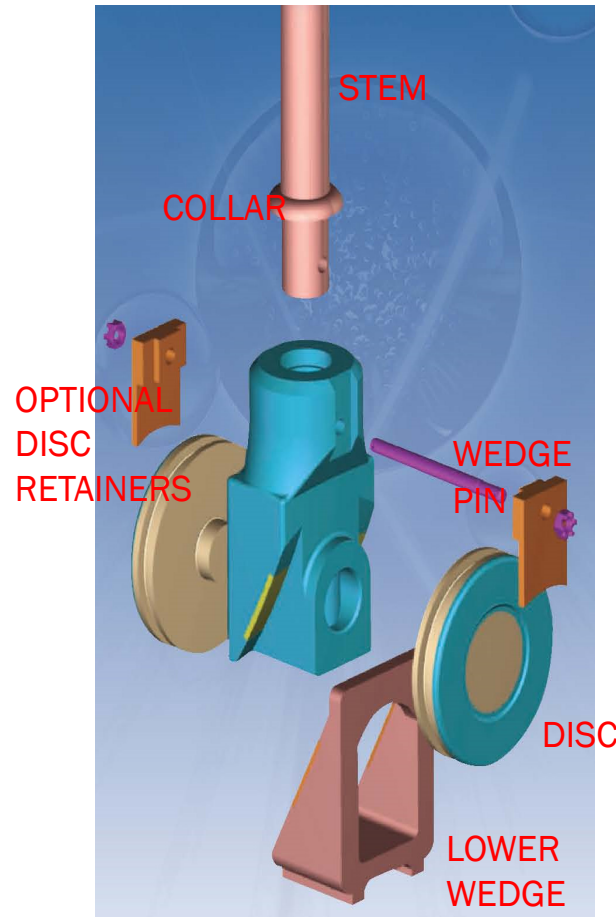
STEM-WEDGE CONNECTION

Motor Actuator operational stem torque and thrust is transmitted to the valve internals.

- Stem
- Upper Wedge
- Wedge Pin
- Disc Pack
- Body Seats

Stem / Upper Wedge Interface

- Threaded and Pinned
- Stem Collar - Pressed-on or Integral

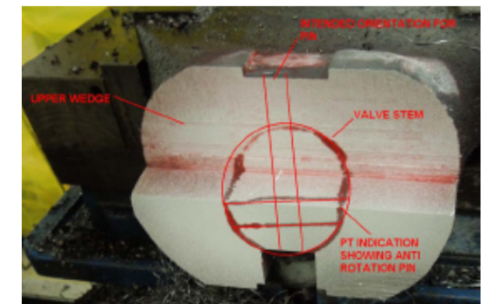
Direct Cause: *The direct cause for the wedge pin shearing is rotation of the valve stem at its threaded connection to the upper wedge connection.*

Root Cause: *Station personnel failed to validate that vendor had torqued the stem to upper wedge connection per vendor's procedures which were modified in response to earlier failures of the same valve design.*
